Last October our French customer welded the TungStuds BTS08 on a CFA. At that test they welded just 10 TungStuds to protect the flights of that auger but in future they will protect the whole flights.

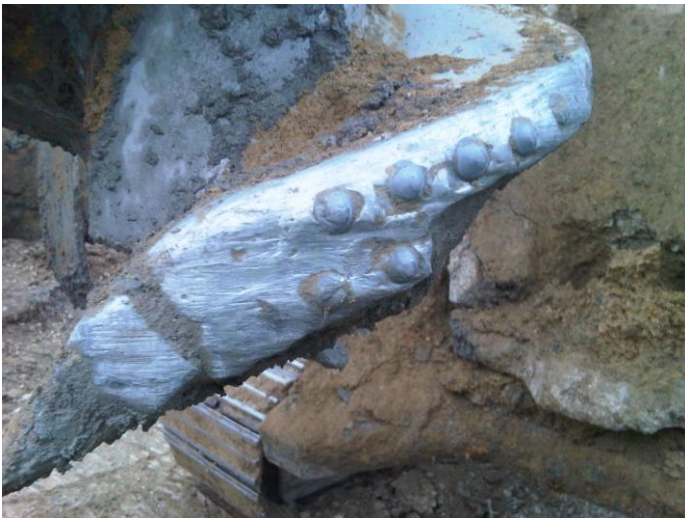
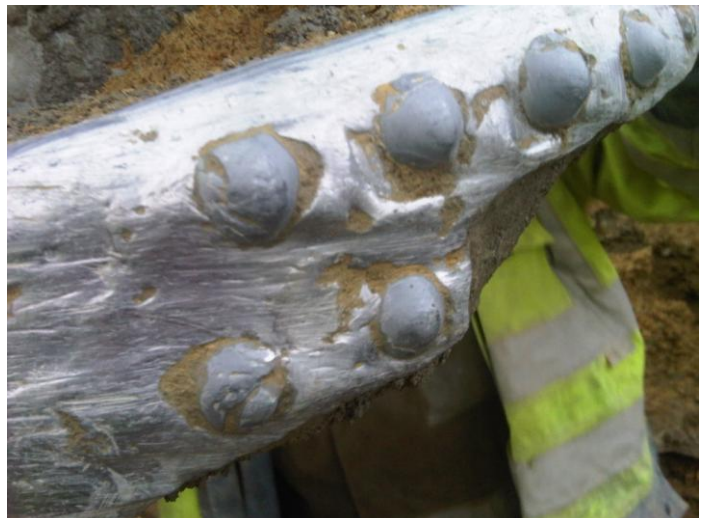
After approximately 1000 borings (secant pilewalls) with 8m depth each the TungStuds were still in good condition as you can see on the following pictures.

The customer was very satisfied with that test and in future he will protect the whole flights with our TungStuds BTS08 as already said, because he doubled the lifetime of his CFA's due to using TungStuds.

Furthermore, we can see that at these TungStuds steel wearing is no problem and therefore they are ideal for applications like this where we can weld just one row and where we will get no Rock-Box-Effect!
